Industry > Amusement Parks and Attractions Application > Shaft Alignment

PRUFTECHNIK ALIGNMENT KEEPS A COASTER ROLLING

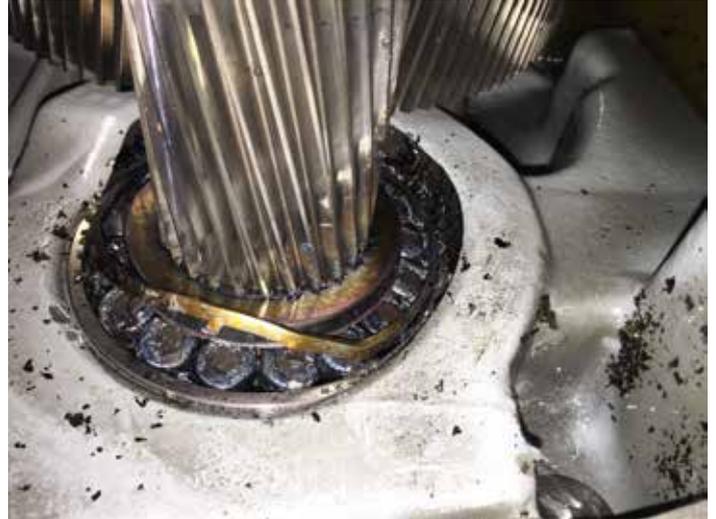
The original bearing failure had occurred on the input shaft of the gearbox. Because as many as 50% of machine failures can be attributed to misalignment, PRUFTECHNIK engineers used the ROTALIGN® Ultra iS to assess the initial alignment condition. They evaluated the coupling tolerances on either side of the gearbox. The fast-moving, rigid coupling on the motor end of the assembly had only a very narrow range of alignment tolerances; the slow-moving, fluid coupling on the sprocket chain side had a little more "wiggle room".

Fig.1 Bearing Failure

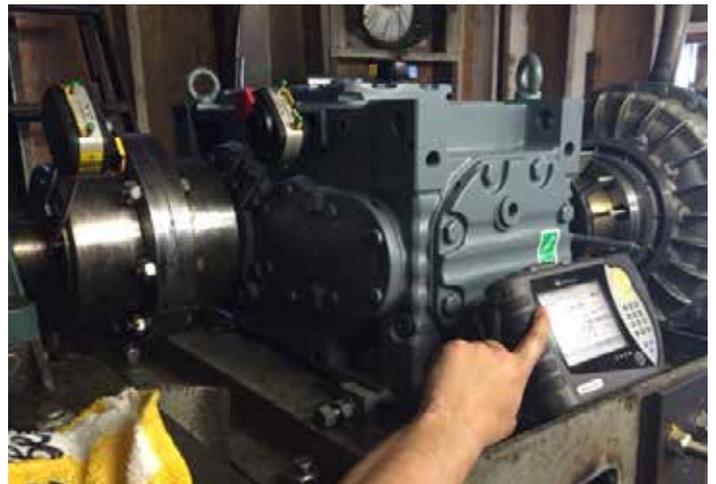
At initial installation, the gearbox showed a misalignment offset of nearly 56 mils, almost 17 times greater than what it should have been. However, using the ROTALIGN® Ultra iS, PRUFTECHNIK engineers were able to improve the alignment of the motor and gearbox coupling to within 0.6 mils, well surpassing the standard described for alignment excellence!

Likewise, the gap or angled disjunction at the motor coupling started out at 18 mils. Following the alignment, the gap was reduced to 1.4, again well into the range defined as an “excellent” alignment.

Fig. 2 Assembly alignment assessment with ROTALIGN® Ultra iS

The initial assessment exposed an alignment far outside the acceptable range. However, by using the ROTALIGN® Ultra iS, PRUFTECHNIK engineers were able to align the motor, gearbox, and chain assembly to well within tolerances defined as "excellent" for this setup. But they did not stop there. Following the alignment, PRUFTECHNIK's engineers used the VIBXPERT® II and OMNITREND® software to collect and analyze vibration data. This final step allowed PRUFTECHNIK to examine the overall functioning and health of the gearbox and to verify that proper alignment had indeed been achieved.
