CASE STUDY - CUSTOMER EXPERIENCE

ROTATEK rescues sand plant with help from PRÜFTECHNIK

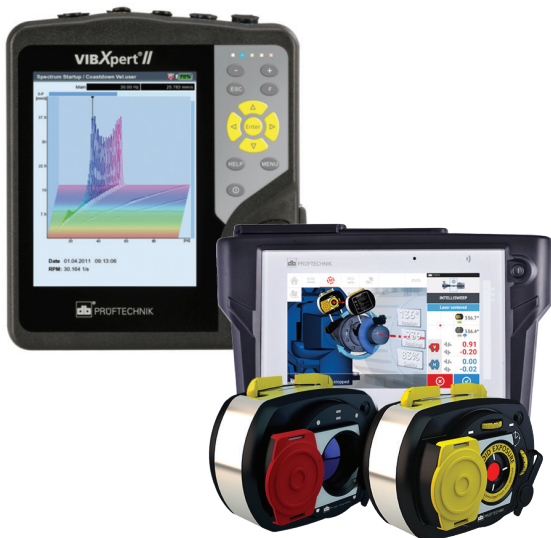
While his team could use a laser tracker to do a shaft alignment, it would take longer. Instead, they use the RotAlign Touch to do the same job in much less time.

“It’s faster to dimension the equipment. It’s faster to measure, see your results, and see your corrections,” he states. “You can also see your live moves right on the screen.”

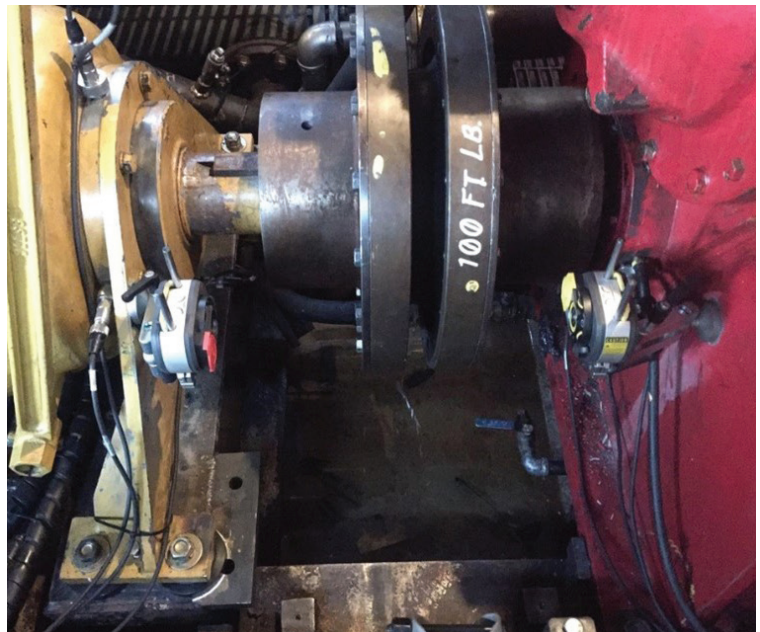
The Live Trend setup

Santos and his team mounted the SensAlign heads and used Live Trend to monitor positional movement between the PTO and the gear pump.

The team went above deck and recorded vibration data through different speeds and processes. Santos and his team confirmed that there was no excessive positional travel.

“I think the movement that we may have recorded was less than two-thousandths of an inch. And they were working the barge hard—it’s not a delicate process when they’re mining for sand,” Santos says. “But we have Live Trend data to show that they didn’t have excess positional movement.”

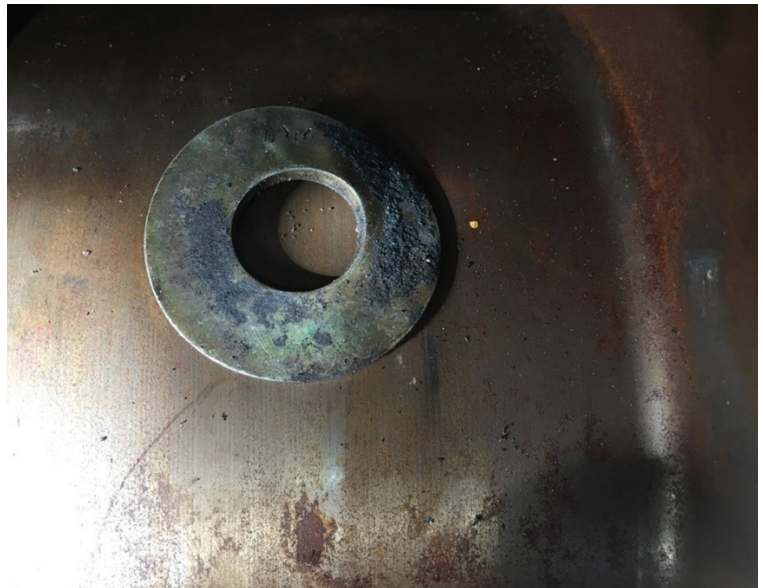
The equipment had cupped washers because the through-hole was so large that when it was bolted together, it mushroomed the washers.
