Industry > Amusement Parks and Attractions Application > Shaft Alignment

PRUFTECHNIK ALIGNMENT KEEPS A COASTER ROLLING

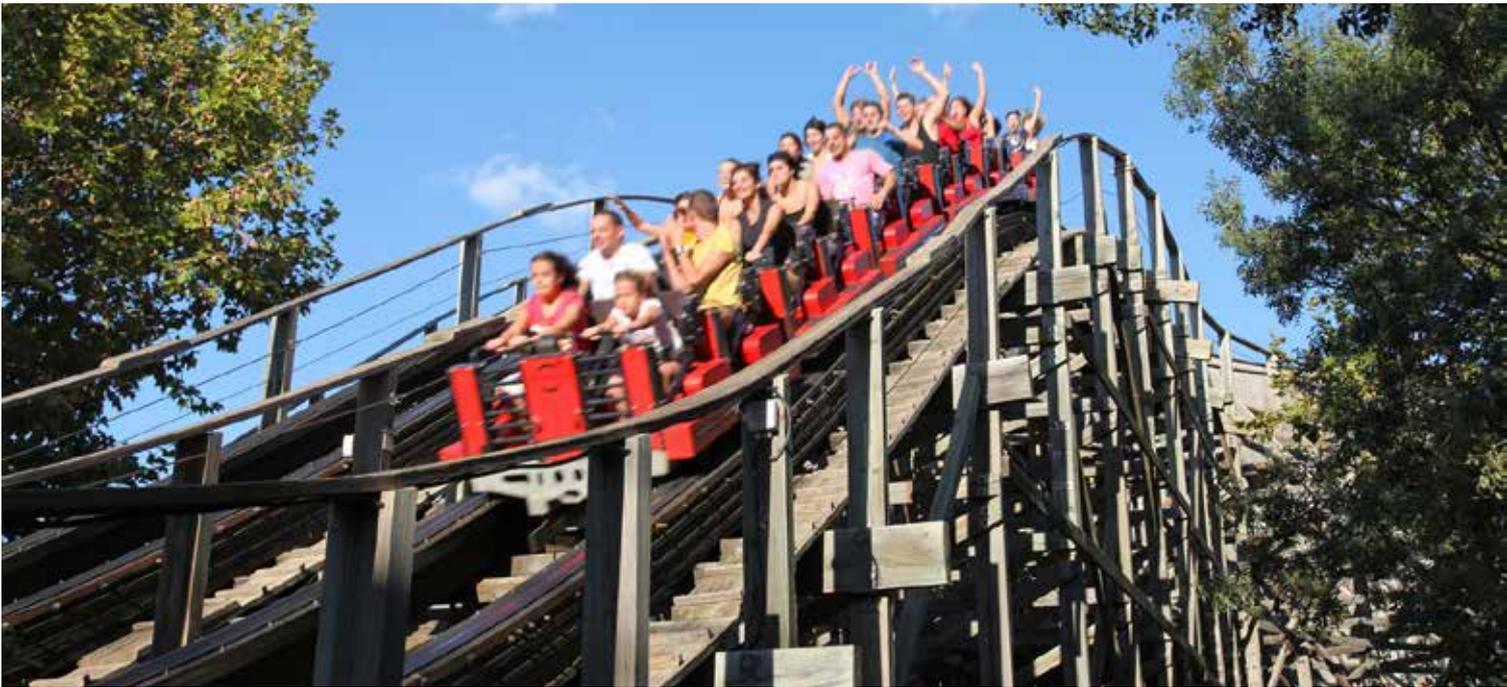
Fig.1 Bearing Failure

To welcome riders for the busy 2016 summer season, an American amusement park roller coaster required alignment. At the end of last season the coaster's driving assembly, the mechanism that pulls cars up the hill at the start of the ride, experienced a bearing failure. Damage to the gearbox was significant. Following the manufacturer's repair and overhaul of the damaged parts, the gearbox had to be re-installed. Proper alignment was crucial. The park operators called in PRUFTECHNIK to make sure this alignment was done right.

The original bearing failure had occurred on the input shaft of the gearbox. Because as many as 50% of machine failures can be attributed to misalignment, PRUFTECHNIK engineers used the ROTALIGN® Ultra iS to assess the initial alignment condition. They evaluated the coupling tolerances on either side of the gearbox. The fast-moving, rigid coupling on the motor end of the assembly had only a very narrow range of alignment tolerances; the slow-moving, fluid coupling on the sprocket chain side had a little more "wiggle room".

The initial assessment exposed an alignment far outside the acceptable range. However, by using the ROTALIGN® Ultra iS, PRUFTECHNIK engineers were able to align the motor, gearbox, and chain assembly to well within tolerances defined as "excellent" for this setup. But they did not stop there. Following the alignment, PRUFTECHNIK's engineers used the VIBXPERT® II and OMNITREND® software to collect and analyze vibration data. This final step allowed PRUFTECHNIK to examine the overall functioning and health of the gearbox and to verify that proper alignment had indeed been achieved.

At initial installation, the gearbox showed a misalignment offset of nearly 56 mils, almost 17 times greater than what it should have been. However, using the ROTALIGN® Ultra iS, PRUFTECHNIK engineers were able to improve the alignment of the motor and gearbox coupling to within 0.6 mils, well surpassing the standard described for alignment excellence!

Likewise, the gap or angled disjunction at the motor coupling started out at 18 mils. Following the alignment, the gap was reduced to 1.4, again well into the range defined as an “excellent” alignment.
