PRUFTECHNIK Service Center

Reducing Cardan Errors for Low-Vibration Operation of Coupled Machines

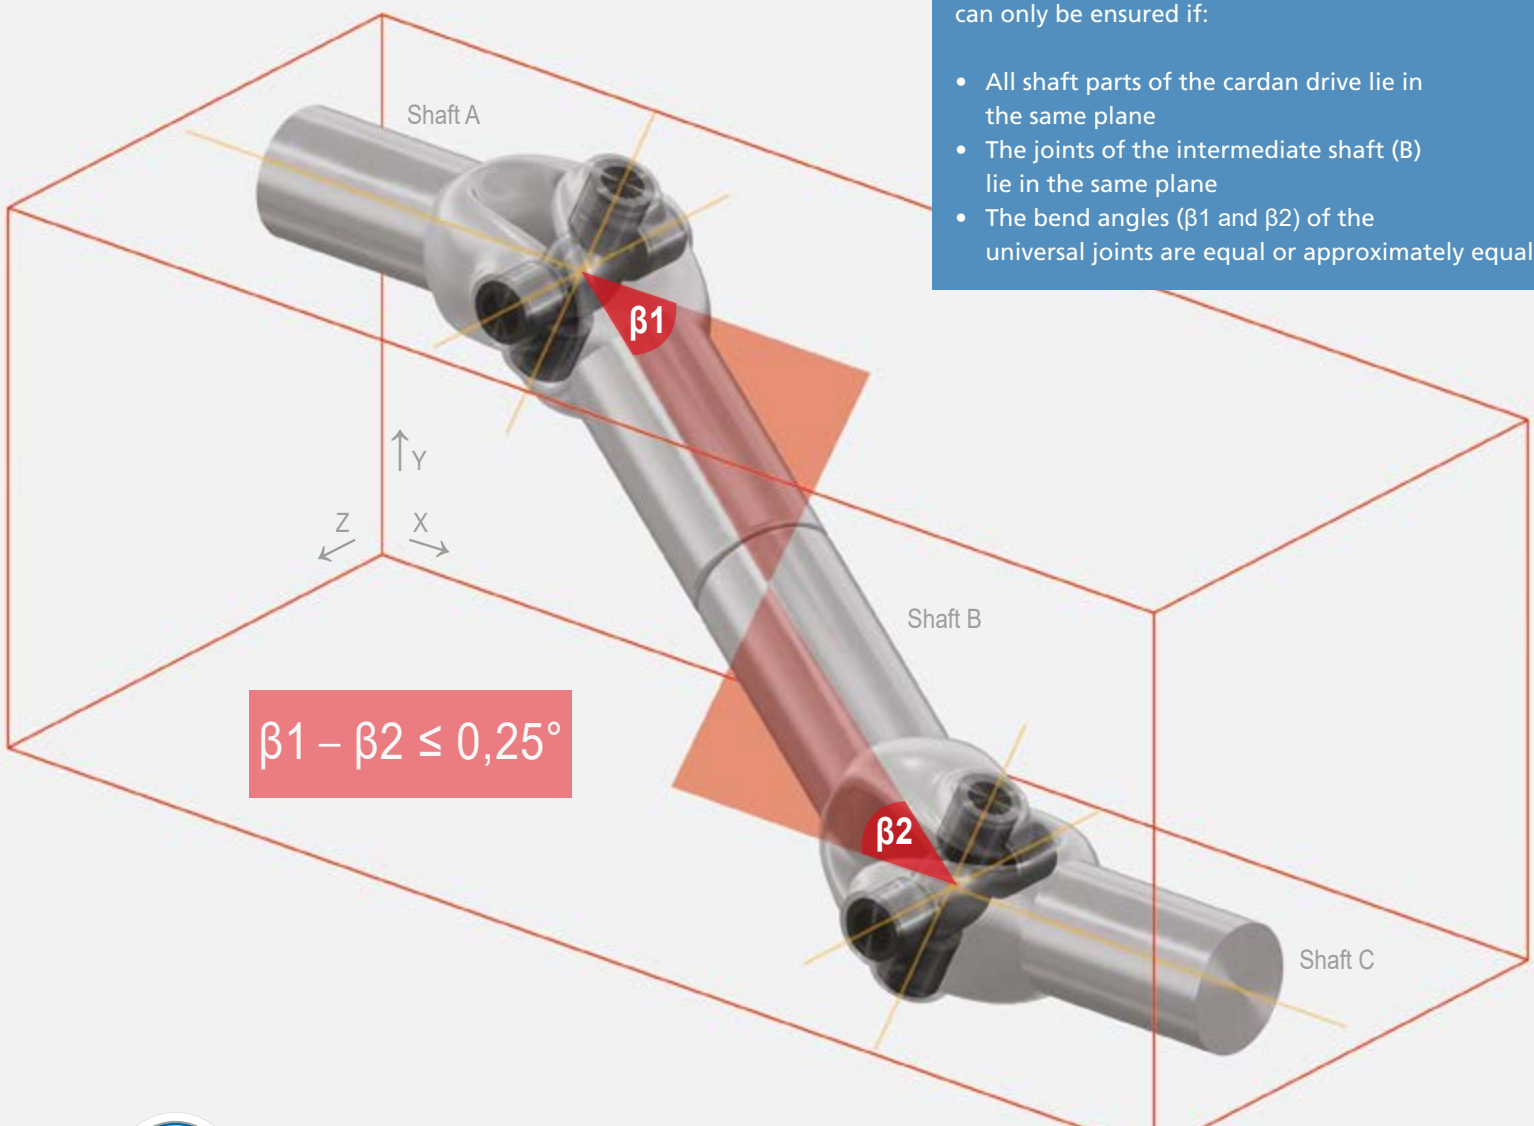
Synchronous run of both shaft parts (A and C) can only be ensured if:

- All shaft parts of the cardan drive lie in the same plane
- The joints of the intermediate shaft (B) lie in the same plane
- The bend angles (β_1 and β_2) of the universal joints are equal or approximately equal

The 3 shafts and the 2 joints of the cardan must lie in the same plane. The bend angles β_1 and β_2 of the universal joints 1 and 2 must be approximately equal.

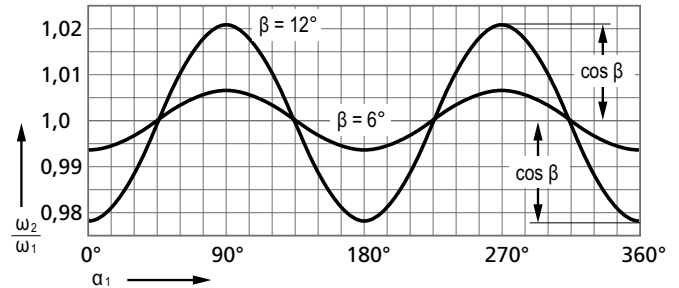
During one revolution of shaft A, the acceleration and deceleration maximum is passed twice in shaft B. This Cardan error means a sinusoidal variation in the angular speed that can be calculated using this function for every rotational position.

$$\omega_2 = \frac{\cos \beta}{1 - \sin^2 \alpha_1 \cdot \sin^2 \beta} \cdot \omega_1 \quad \left[\frac{1}{s} \right]$$

Here, α_1 is the angle of rotation of drive shaft 1.
 β is the bend angle of the joint.

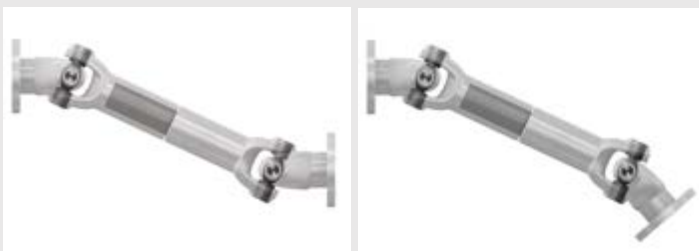
The irregular movement in shaft B can be compensated, if two universal joints with a phase shift of 90° are used in the cardan drive in Z- or W-arrangement.

In this case, shaft part C runs synchronously with shaft A.

Cardan shaft in Z-arrangement

Cardan shaft in W-arrangement

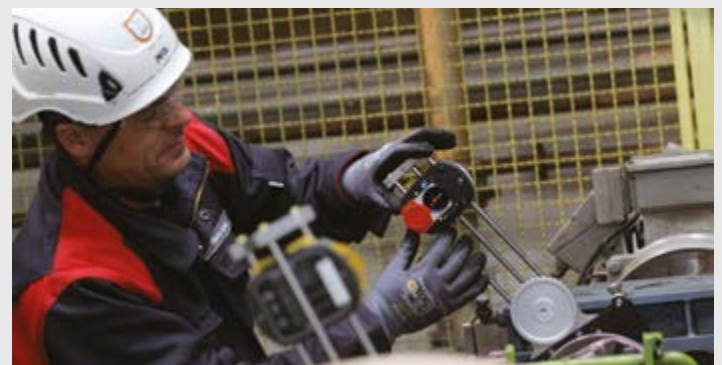
Laser-optical alignment of an installed cardan shaft

However, achieving perfect compensation is difficult in reality and requires competent laser-optical alignment of cardan shafts in the removed as well as installed state.
